memorandum

Date: Sep. 12, 2022

Re: Coastal Geologic Site Visit Memo for Shore Friendly Kitsap Program – Final James W. Johannessen

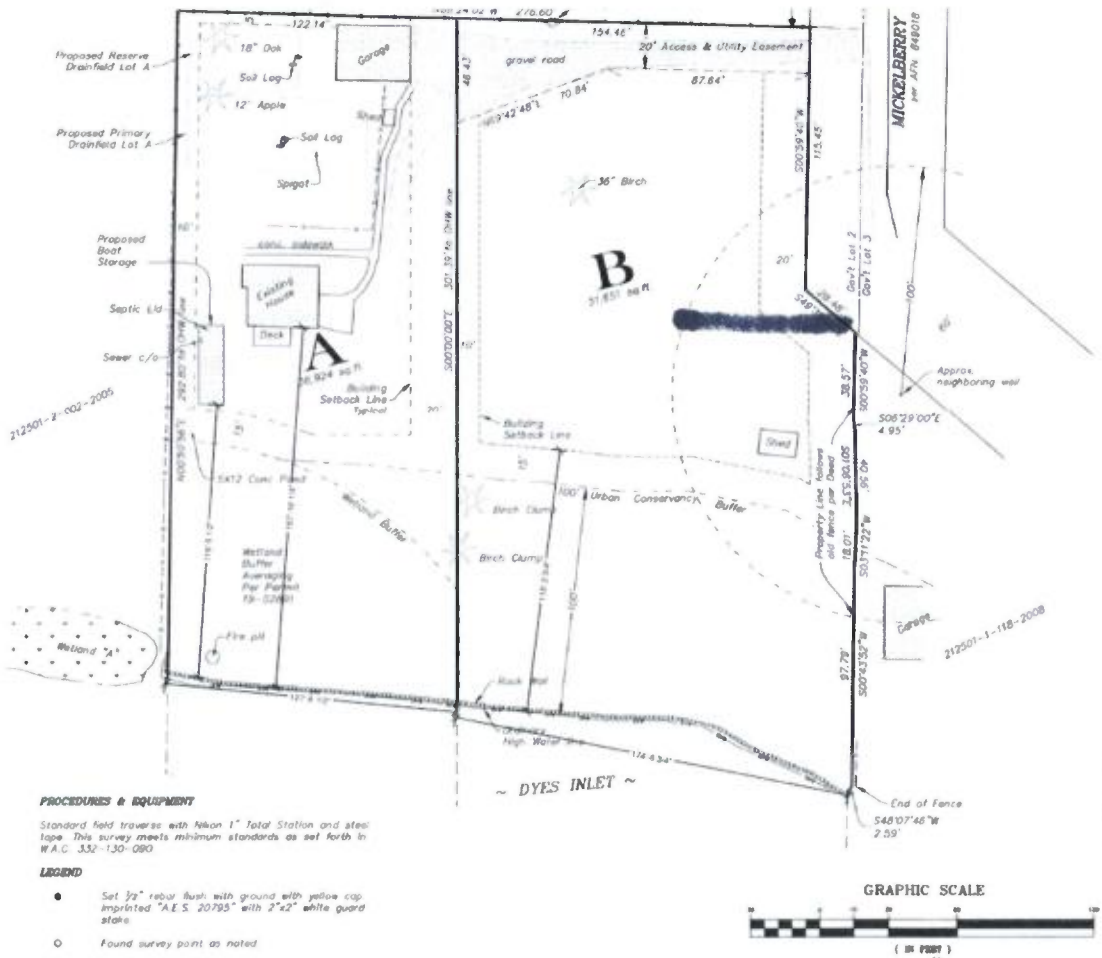
Figure 2. Excerpt of survey map by AES Consultants 2019 (setback distances added).

The minimum setback from the rockery wall along the north shore of the embayment to the existing house was measured at 156 FT and the boathouse was setback at least 122 FT. We understand you have permits almost fully approved for a new house on the eastern parcel. Drawings show an approximately 115 FT house setback from the low bank for the new building. We also understand the existing and proposed new septic drainfields are/will be located landward of the houses.

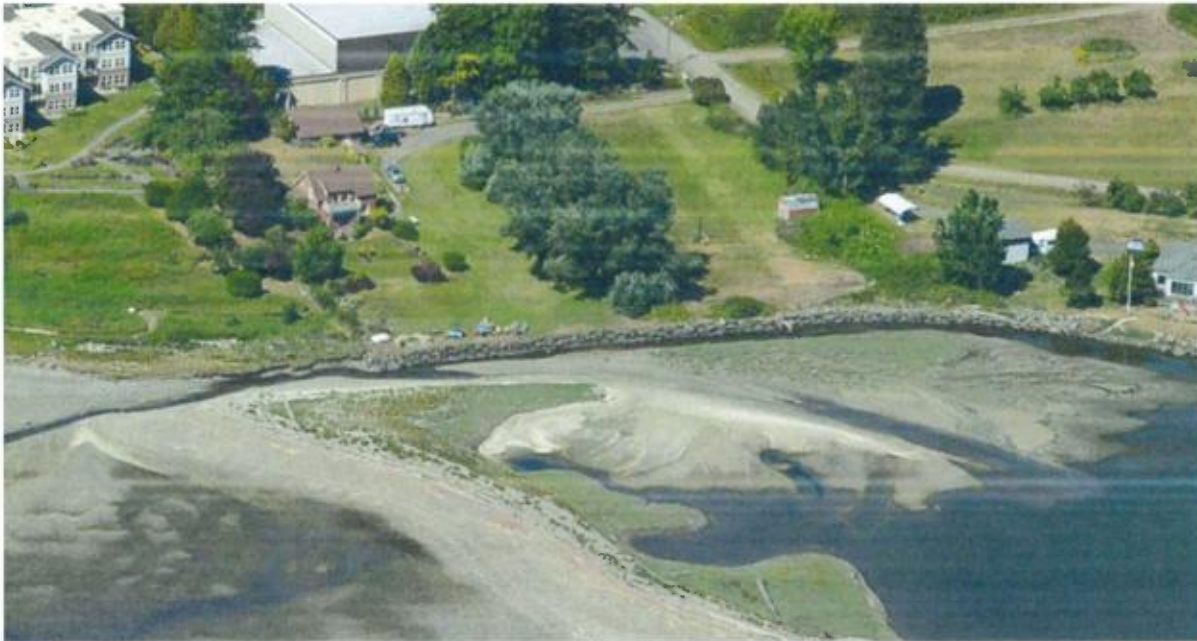
Figure 3. Oblique aerial photo excerpt of the two parcels and estuary inlet area from 2016 (WA Dept. of Ecology). House on western parcel is visible in center left and the eastern parcel extends up to the road corner.

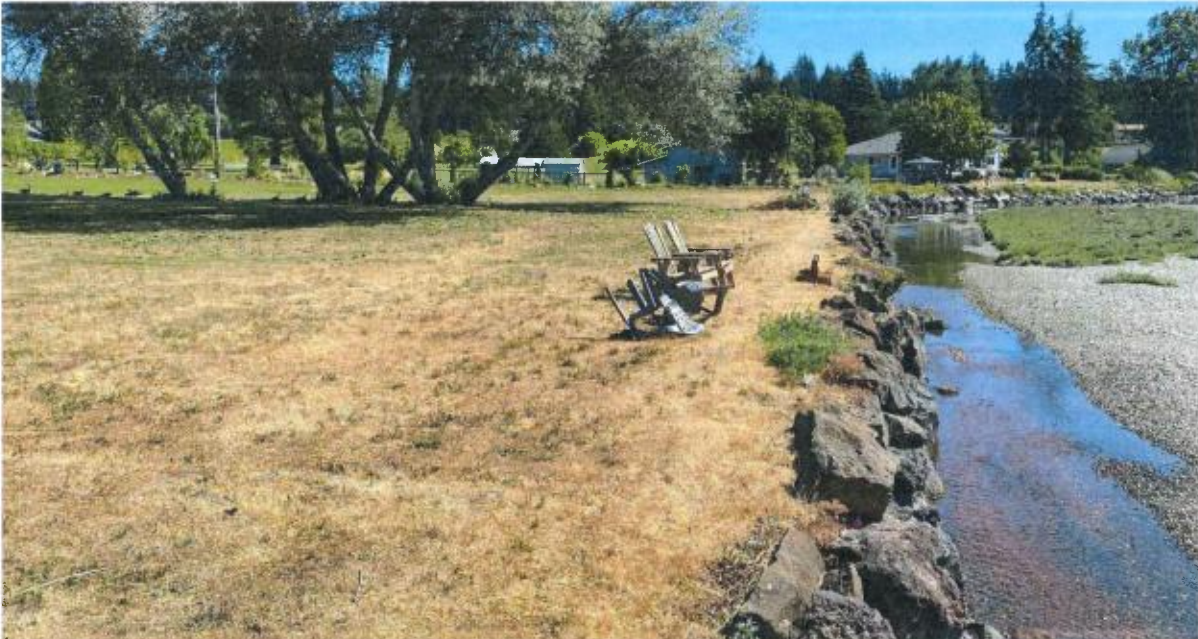
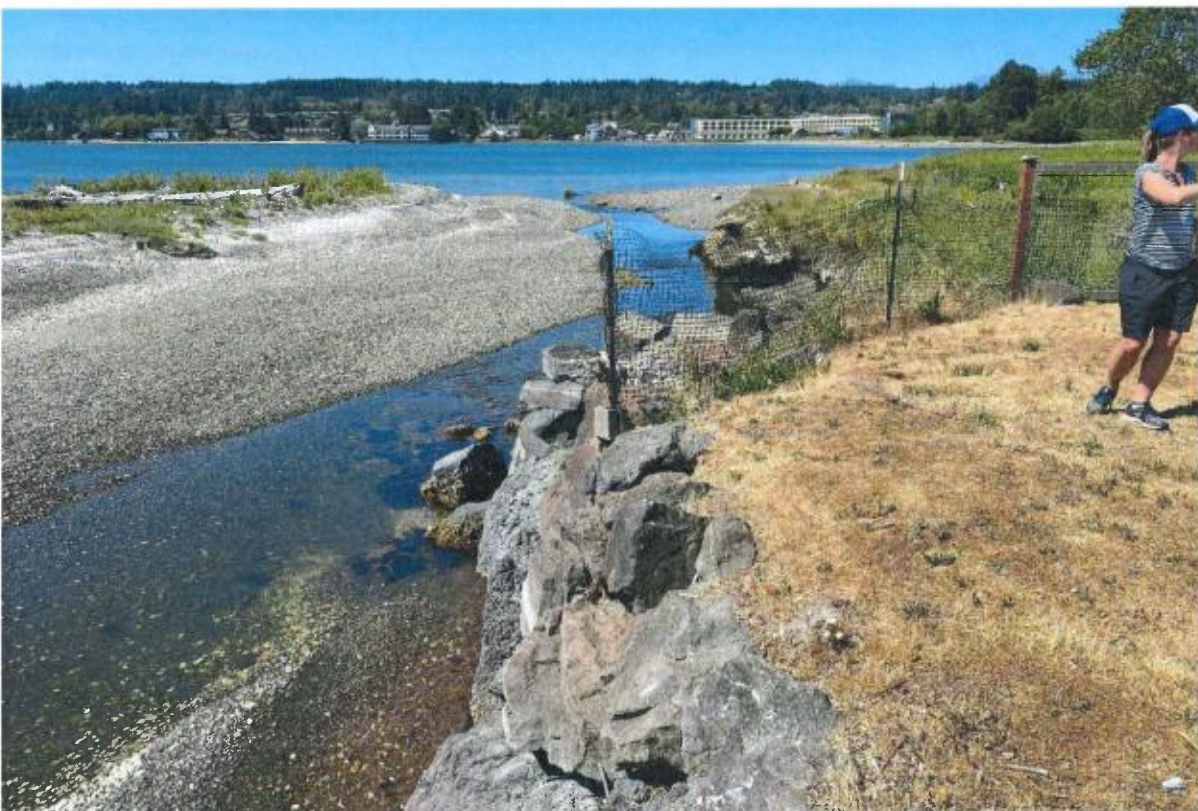
Photo Page

A rockery wall was present along the entire shore of the two parcels at the site. This type of rock wall is also called a shoreline bulkhead or shore armor. The rockery wall ran along the full shore length of both parcels of 300 FT. The rockery wall was 6-7 FT high above grade in the lagoon and stood almost vertical. The wall was composed of 2-4 FT basalt boulders that were mostly angular but also contained partially rounded boulders. Overall, the rockery wall was in fair condition, but several rocks were displaced a small amount outside of the west end.

The west end of the rockery wall near the west property line had toppled and you informed me you had some planning work completed towards repairing this corner. I also understand that county permitting was not completed, and you may not be going forward with this repair.

Photo Page, Freidman site, taken August 17, 2022. Upper image is looking east, lower looking west.

Shore armor removal is entirely feasible at the site with the substantial existing and proposed setbacks, and considering that the septic drain fields will be landward of the houses. There is very little elevation difference to work with other than the 6-7 FT high bank along the current estuary shore.

Several different elevation benches for saltmarsh growth could be established as part of the rockery wall removal and restoration. Stepping up in elevation to the north would allow for a moderate area of marsh growth with a gradual sloped bank higher up and revegetation of native species included in a restoration plan.

A new rockery return wall would be needed with armor and fill removal along the eastern shore in order to ensure that potential erosion did not affect the eastern neighbor's parcel. A return wall is a short reach of bulkhead wall that extends away from the shore, and in this case would be constructed out of salvaged rock and would run near the eastern property line. The return wall details would need to be determined with additional analysis and design work but would likely be on the order of 10-20 FT long.
