Rose Environmental

December 3, 2021

Subject: Pre-Demolition Asbestos & Lead Paint Survey, 6 Dwellings & 1 Church, Port Orchard, WA

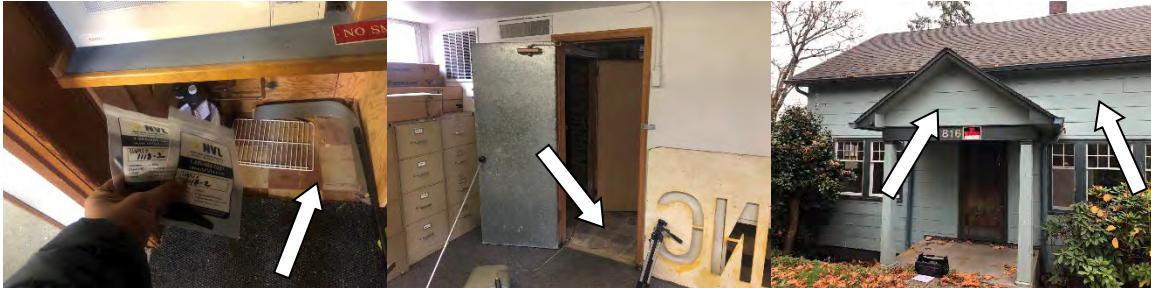
- Approximately 100 square feet of red 9x9” vinyl composition tile in the Entry flooring (underneath the carpet) contained approximately 15% chrysotile asbestos in the tile.
- Approximately 100 square feet of tan 9x9” vinyl composition tile in the Entry flooring (underneath the carpet) contained approximately 12% chrysotile asbestos in the tile.

- Approximately 200 square feet of tan/red patterned 9x9” vinyl composition tile in the Basement East Room flooring contained approximately 7% chrysotile asbestos in the tile.

- Approximately 2,400 square feet of light green cement asbestos board (CAB) exterior siding contained approximately 20% chrysotile asbestos in the CAB.
- Approximately 80 square feet of tan vinyl sheet flooring in the Kitchen contained approximately 7% chrysotile asbestos in the vinyl sheet flooring (under the hardwood flooring).
- White texture on the Living Room and Bathroom GWB contained approximately 3% chrysotile asbestos in the texture.

**Representative Photos: 717 Sidney Ave - Red & Tan 9x9” VCT (L)
Tan/Red patterned VCT (C) & 816 Sidney Ave Light Green CAB (R)**

Asbestos-containing materials are required to be removed and disposed of in accordance with Washington State Regulations prior to any demolition, renovation, or remodeling that would disturb these materials. Washington State Department of Labor and Industries and PSCAA require that the abatement be performed using Certified Asbestos Workers under the direct on-site supervision of a Certified Asbestos Supervisor.

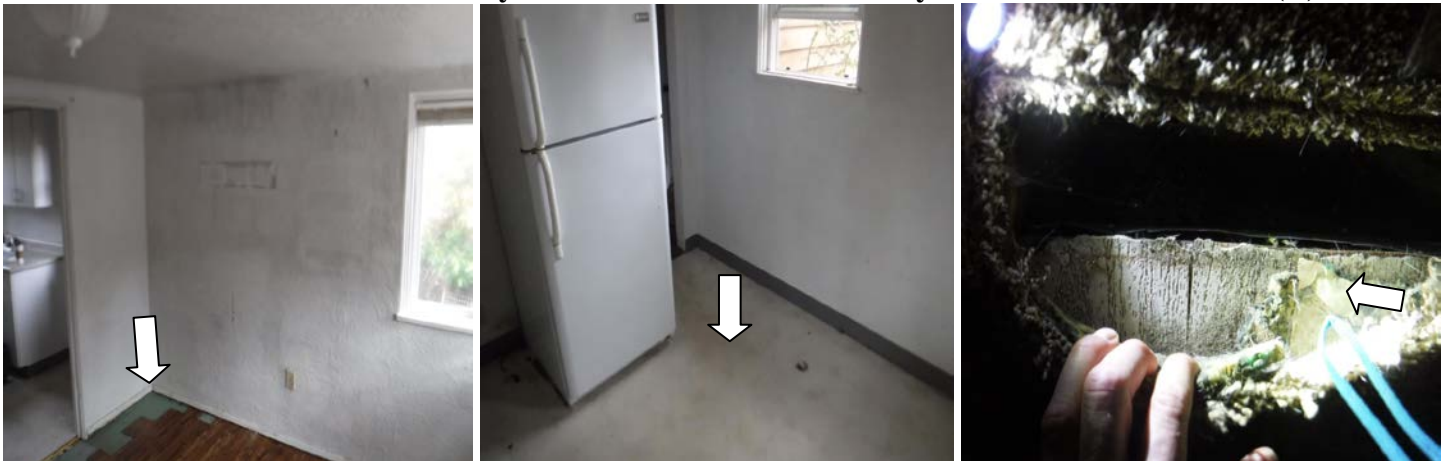
- A) Approximately 250 square feet of **concealed green sheet vinyl flooring**, as found below white tile-patterned sheet vinyl and particleboard overlay in the Kitchen and under brown “wood-patterned” vinyl plank flooring in the Living Room, **contained 3% chrysotile asbestos.**
- B) Approximately 200 square feet of **concealed white “wood-patterned” sheet vinyl flooring**, as found below carpet in the Main Floor Southwest Bedroom and adjacent Hallway, **contained 2% chrysotile asbestos.**

Photos 1-3: Representative Photos of Green Sheet Vinyl (Under Vinyl Plank Flooring) in Living Room (L), White Sheet Vinyl over Plywood and Concealed Green Sheet Vinyl in Kitchen (C), and White “Wood-Patterned Sheet Vinyl in SW Bedroom and Hallway on Main Floor of House (R):

In summary, the results of Rose Environmental's March 23, 2023 asbestos inspection within the 810 Sidney Avenue Residence, confirmed asbestos content greater than one percent in concealed sheet vinyl flooring found below more recent vinyl flooring or carpet layers within the Kitchen, Living Room, Hallway, and Southwest Bedroom on the Main Floor (see above for details).

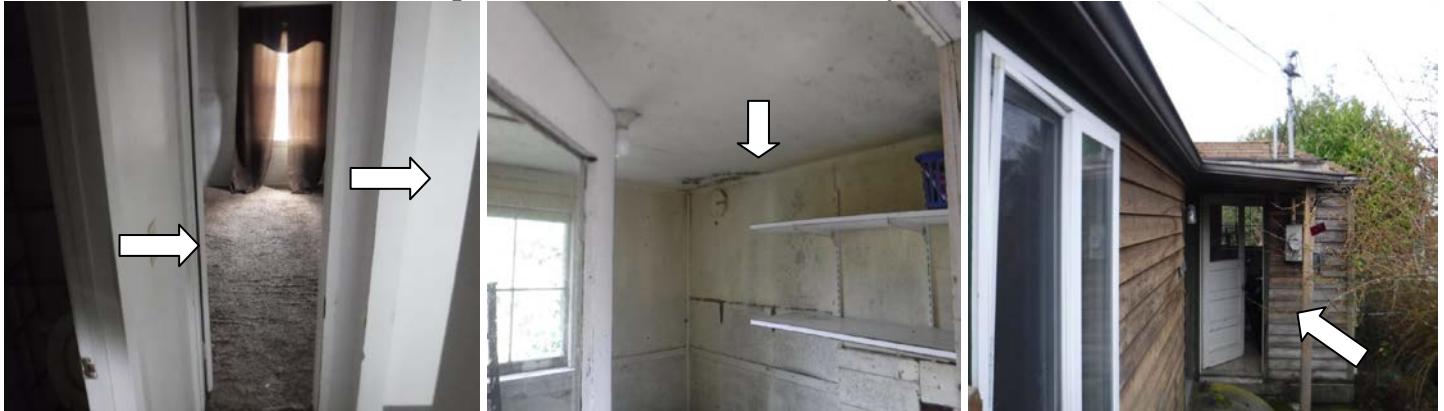
1. White paint + layers, as found on the plaster walls and ceilings throughout the Main Floor, contained 0.040 to 0.58% lead.
2. Cream paint, as found on the GWB within the North Exterior Utility Room, contained 0.18% lead.
3. Light green paint, as found on the wood threshold within the North Exterior Utility Room, contained 0.078% lead.
4. Cream and green paint layers, as found on the wood trim/door within the North Exterior Utility Room, contained 1.7% lead.
5. White paint, as found on the wood trim/door within the Main Floor Southwest Bedroom contained 0.057% lead.

Photos 4-6: Representative Photos of Lead-Containing Paint on Wood Trim and Plaster Walls at Southwest Bedroom and Hall (L), and Cream Paint on GWB Walls (C), and on Wood Door and Trim Components at North Exterior Utility Room (R):

Disturbance of materials coated with lead-containing paint must be conducted in accordance with worker protection requirements in WAC 296-155, Lead in Construction. In addition, waste streams should be evaluated for lead content prior to disposal by EPA Toxicity Characteristic Leachate Procedure (TCLP) to ensure RCRA classifications are considered. Rose Environmental's paint survey is not intended to identify or mitigate lead dust hazards to residents (as required by EPA's Lead Renovation, Repair, and Painting (RRP) Program).
