Taylor Road Bridge – Alternate Project Request

TAYLOR ROAD BRIDGE

ALTERNATIVE MAJOR MAINTENANCE PROJECT REQUEST

Prepared for: Kitsap County Public Works

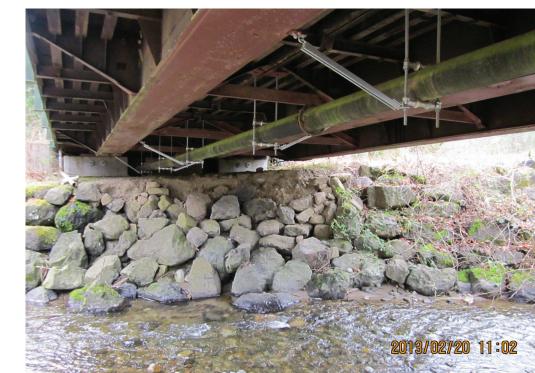
Intersecting	CHICO CREEK
Paint Failure on Girder/Deck Soffit Funding	
Photo Type:	(none)
Orientation:	E
Date:	3/24/2019
Repairs:

Paint Failure on Girder/Deck Soffit

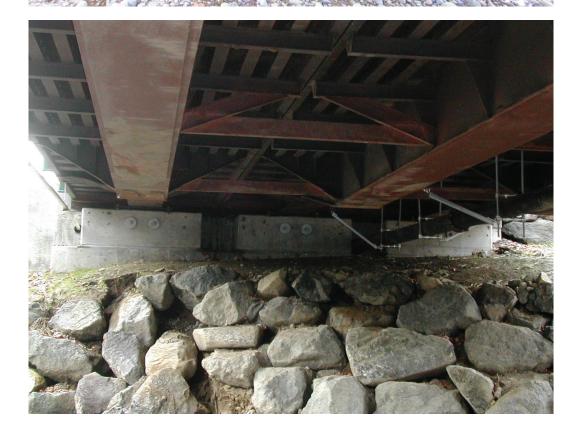
w							
Funding							
Photo Type:	(none)						
Orientation:	UP						
Date:	3/24/2019						
Repairs:							
Superstructure View

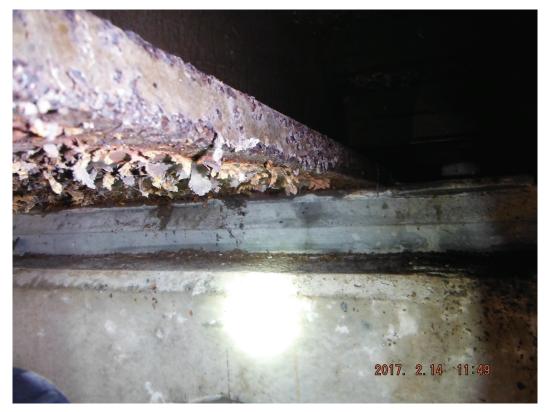
Intersecting CHICO CREEK
Close Up Paint
Failure with Early
Stage Section
Loss
Funding
Photo Type: (none)
Orientation:
Date: 3/24/2019
Repairs:
Close Up Paint Failure with Early Stage
Section Loss

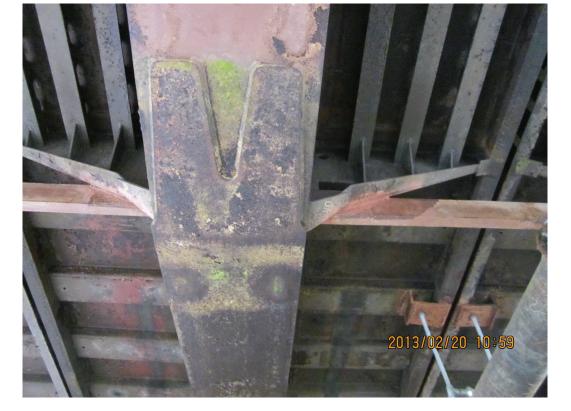
Close Up Paint Failure

ailure						
	Funding					
	Photo Type:	(none)				
	Orientation:	UP				
	Date:	3/24/2019				
	Repairs:					
	Close Up Paint	Failure
