# East Port Orchard Regional Stormwater Drainage Study

Public Meeting

November 16, 2004

**R·W·BECK**

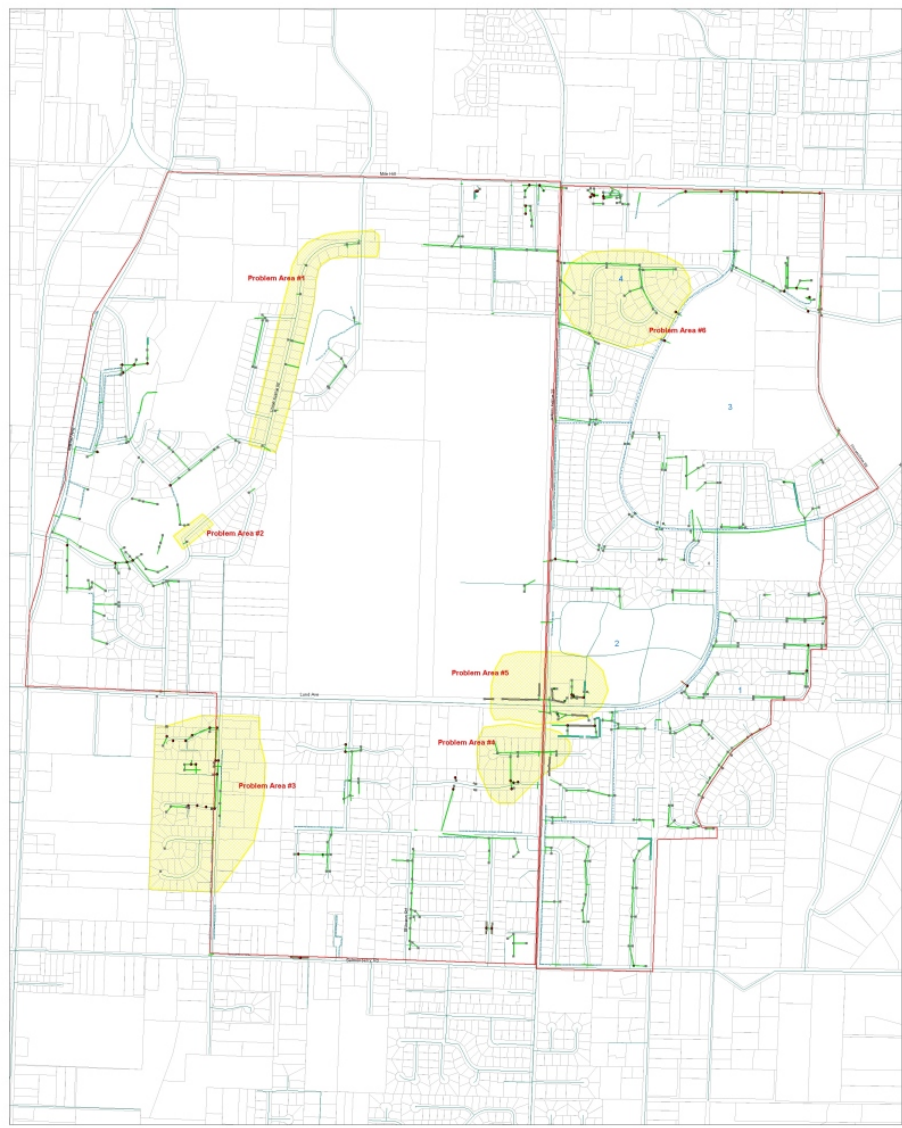
# Priority Problems

- 37 flooding problems were identified
- Problems prioritized based on:
  - Compliance with federal and state regulations
  - Threat to public safety, health, and welfare
  - Potential to damage property or impact public facilities
  - Effects on water quality
- Scores 0 to 95
- The six problems with scores of 90 or better were selected for solution development

- EPO Basin Study**
- Problem Areas - RW Beck 11-2004
  - CB 1
  - CB 2
  - CMH
  - OWS
  - OWS 1
  - OWS 2
  - TIDE GATE
  - VAULT
  - Cross Culvert
  - Open Ditch
  - Closed Conveyance
  - Bio-Swale
  - Infiltration Trench

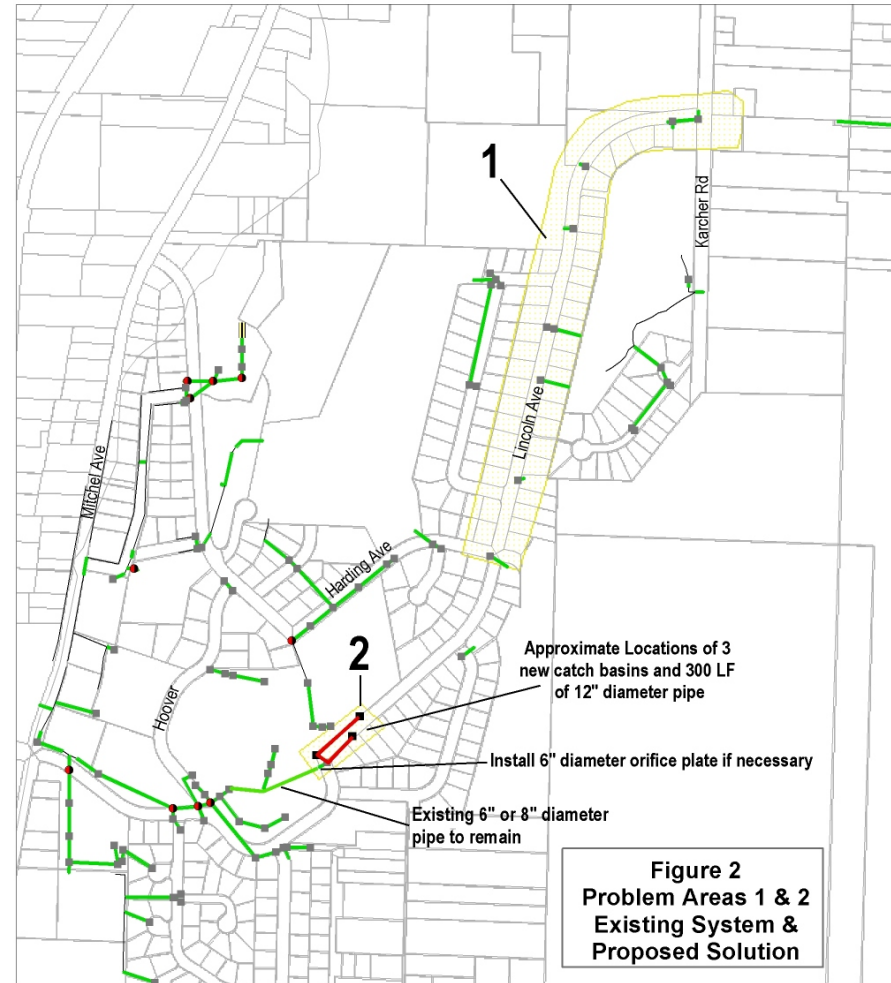
# #1 - Lincoln Ave

- Catch basin grates below roadway elevation
- Property, roadway, and driveway flooding reported

**EPO Basin Summary**

• CB 1	• OWS	▲ TIDE GATE	— DITCH	— TRENCH
• CB 2	• OWS 1	■ VAULT	— PIPE	— SWALE
• CM4	• OWS 2	— CULVERT	— SWALE

Problem Areas - R/W Back 11/2004

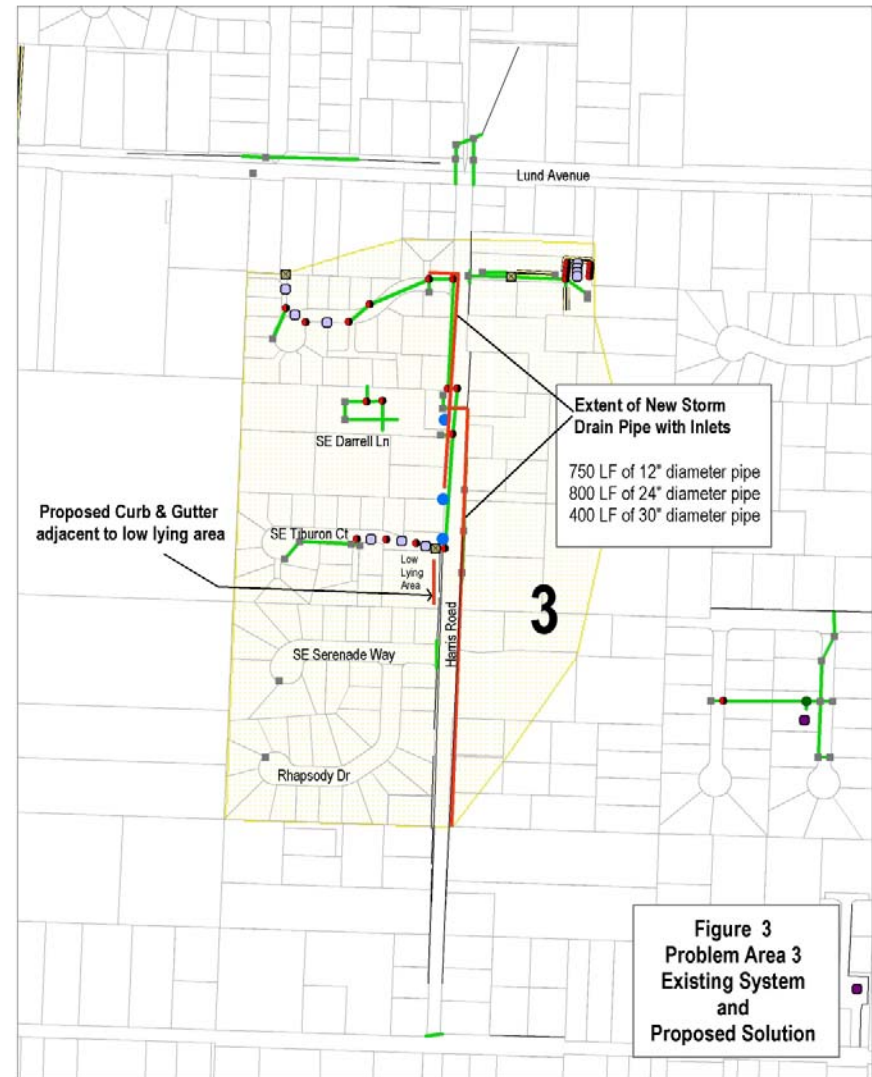
Figure 3  
 Problem Area 3  
 Existing System  
 and  
 Proposed Solution

- Problem Assessment
  - Closed depressions (no outlet for runoff)
  - Informal drainage system or lack thereof
  - Inadequate capacity of some existing ditches, culverts, storm drains

- Solution
  - New storm drain system
  - Curb and gutter adjacent to low-lying area (to collect and convey runoff)

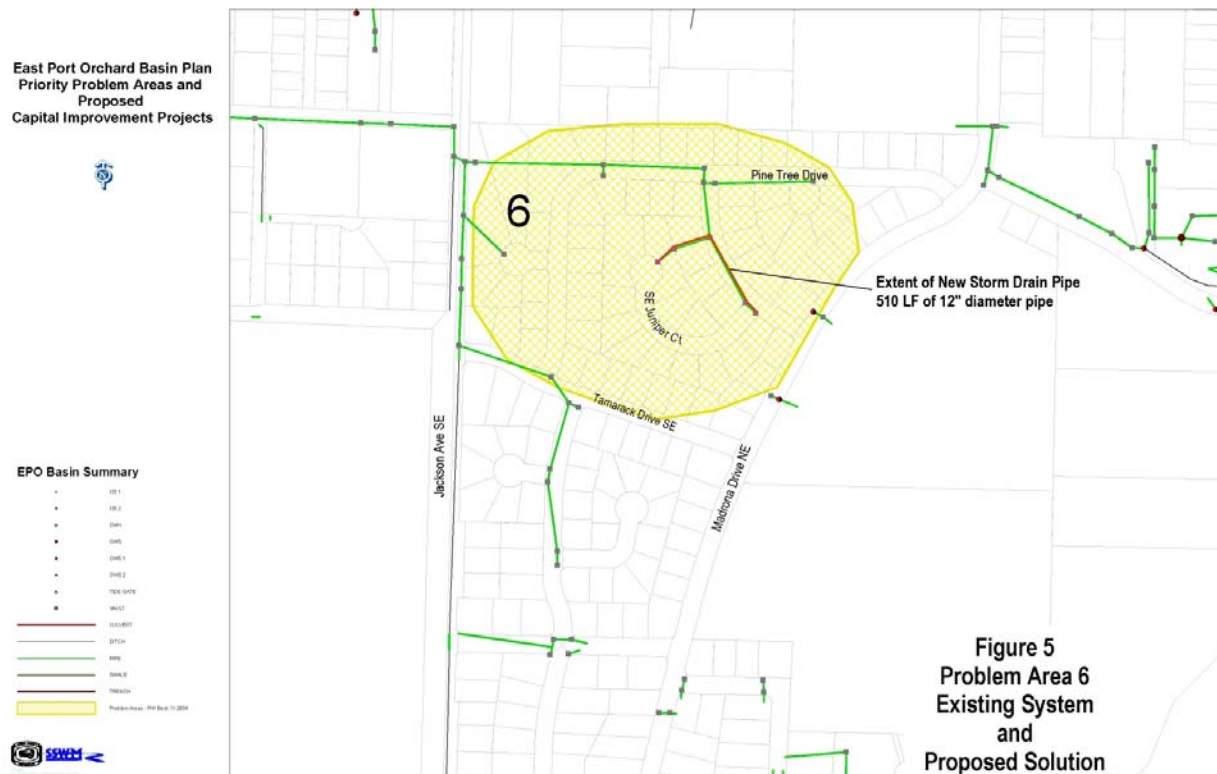
# #6 – Pine Tree Drive

- Problem Description – Street and yard flooding

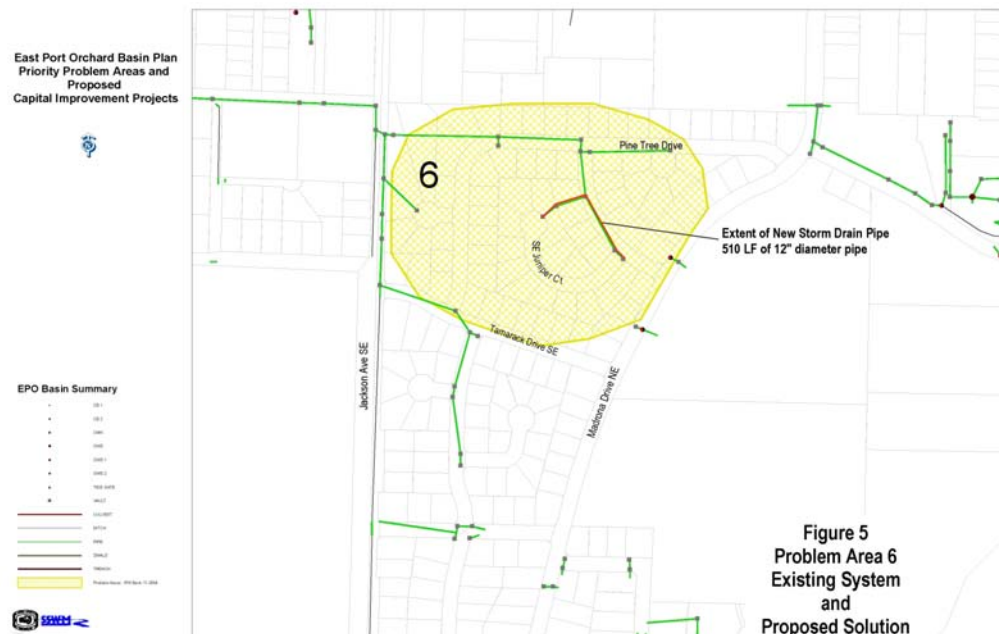
# #6 – Pine Tree Drive

- Most pipes have adequate capacity for 10-year event
- A few pipes appear undersized although reported flooding is more frequent than limited pipe capacity would indicate
