The Truth About Culverts...

Department of Community Development
Your Partner in Building Safe, Resilient, and Sustainable Kitsap County Communities!

WHY AREN'T FISHWAYS A LONG-TERM FISH PASSAGE SOLUTION?

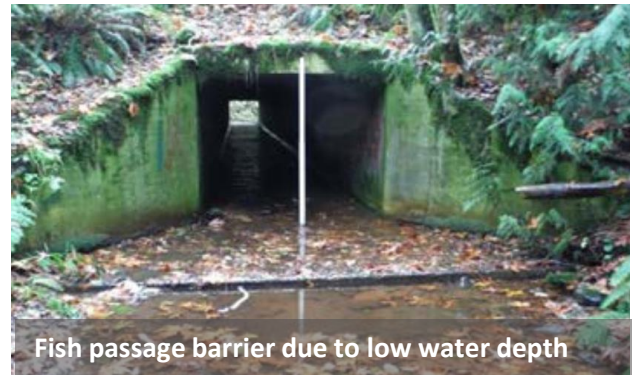
Fish passage barrier due to low water depth

- Water Surface Drop
- High Velocity
- Low Water Depth
- Low vertical clearance

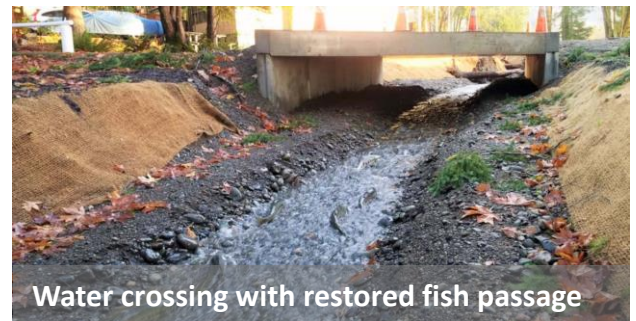
Water crossing with restored fish passage

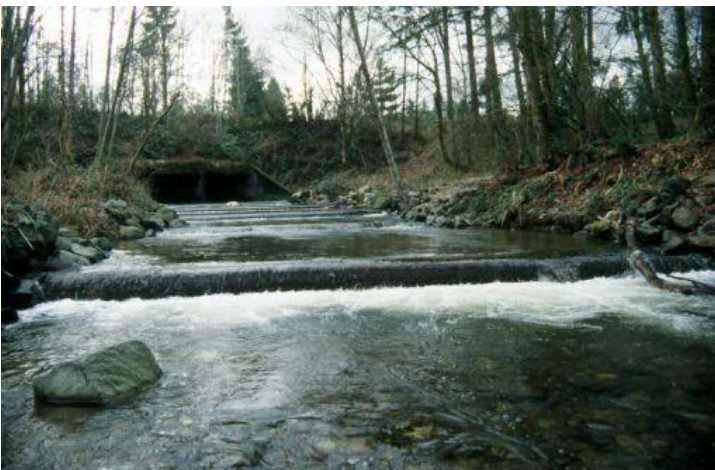
The log weir fishway at the outlet of the Golf Club Hill Road culvert caused additional impacts.

The log weir fishway consisted of over 15 log weirs spaced apart over approximately 1,000 feet downstream of the culvert. Since the culvert had a concrete bottom set at a fixed elevation, it did not allow the streambed of Chico Creek to move up and down vertically and it held back streambed sediment and gravel that would normally move downstream. The culvert was too small and constricted the stream flow, increasing the velocity of the water exiting the culvert. This high-pressure flow eroded a scour pool at the outlet of the culvert.

Over time, the elevation of the streambed downstream of the culvert dropped because new streambed sediment was not coming down to replace it. The water rapidly exiting the culvert continued to scour out the streambed at the culvert outlet. These impacts combined to create a vertical drop out of the culvert that was difficult for fish to navigate.

The log weir fishway was installed as a temporary solution to make up the elevation difference between the perched streambed upstream of the culvert and the degraded streambed downstream of the culvert. The fishway broke up the water surface drop at the culvert outlet into many smaller, more passable drops spaced out over 1,000 feet.

However, the fishway required frequent maintenance and created habitat impacts of its own. For this reason, the culvert replacement project also included removing or cutting the weirs and restoring the stream channel where the fishway was located.

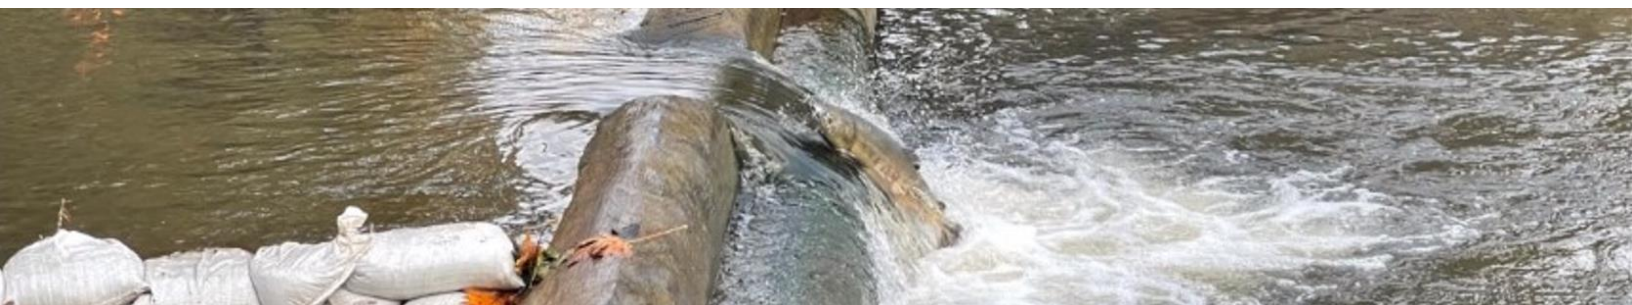
Chum salmon jumping over Chico Creek weir. Photo credit: Alison O'Sullivan, Suquamish Tribe
