Appendix G

Existing Restoration Projects and Scoring Results

Restoration Projects and Scoring Results

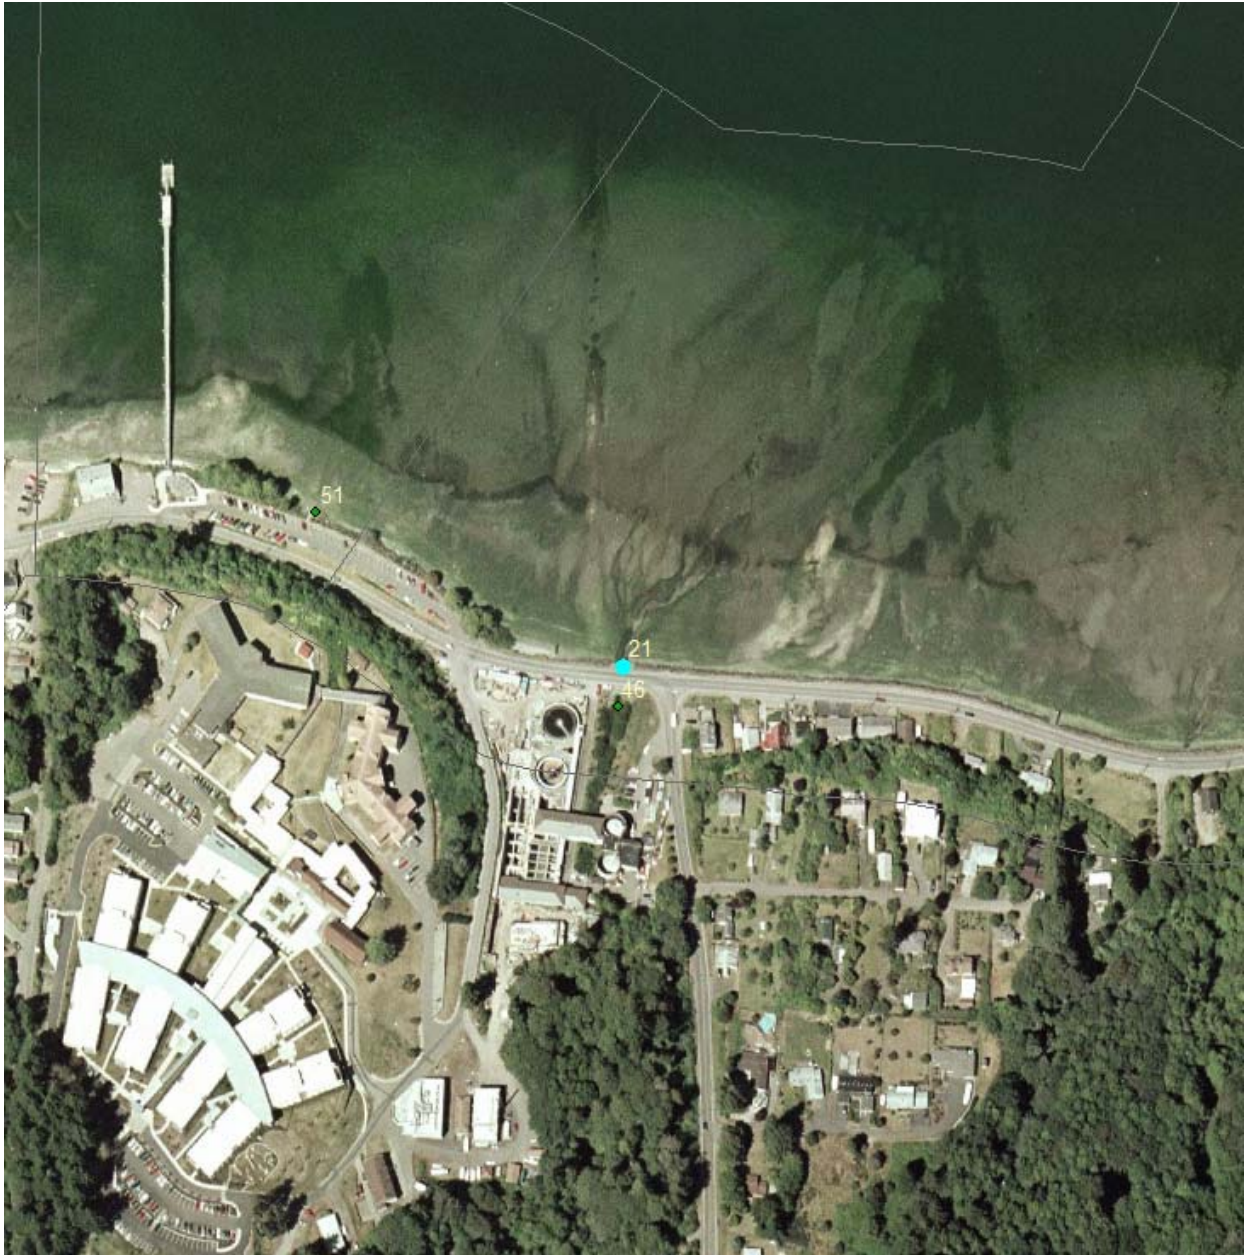
Karcher Creek Culvert Replacement and Invasive Species Removal (Projects 21 and 46). Management strategies include enhancement, creation, and the restoration of site and drift cell processes, because these sites are generally highly disturbed on both the site and landscape scales. Culvert replacement and invasive species removal should work as enhancement actions. However, concerns about reinvasion by undesirable species would be high unless the species was eliminated in source areas in the broader landscape. Also, maintenance of the culvert opening for fish access through the new culvert would depend on adequate flow from the landscape.
