East Port Orchard Drainage Study

EPO Basin Summary

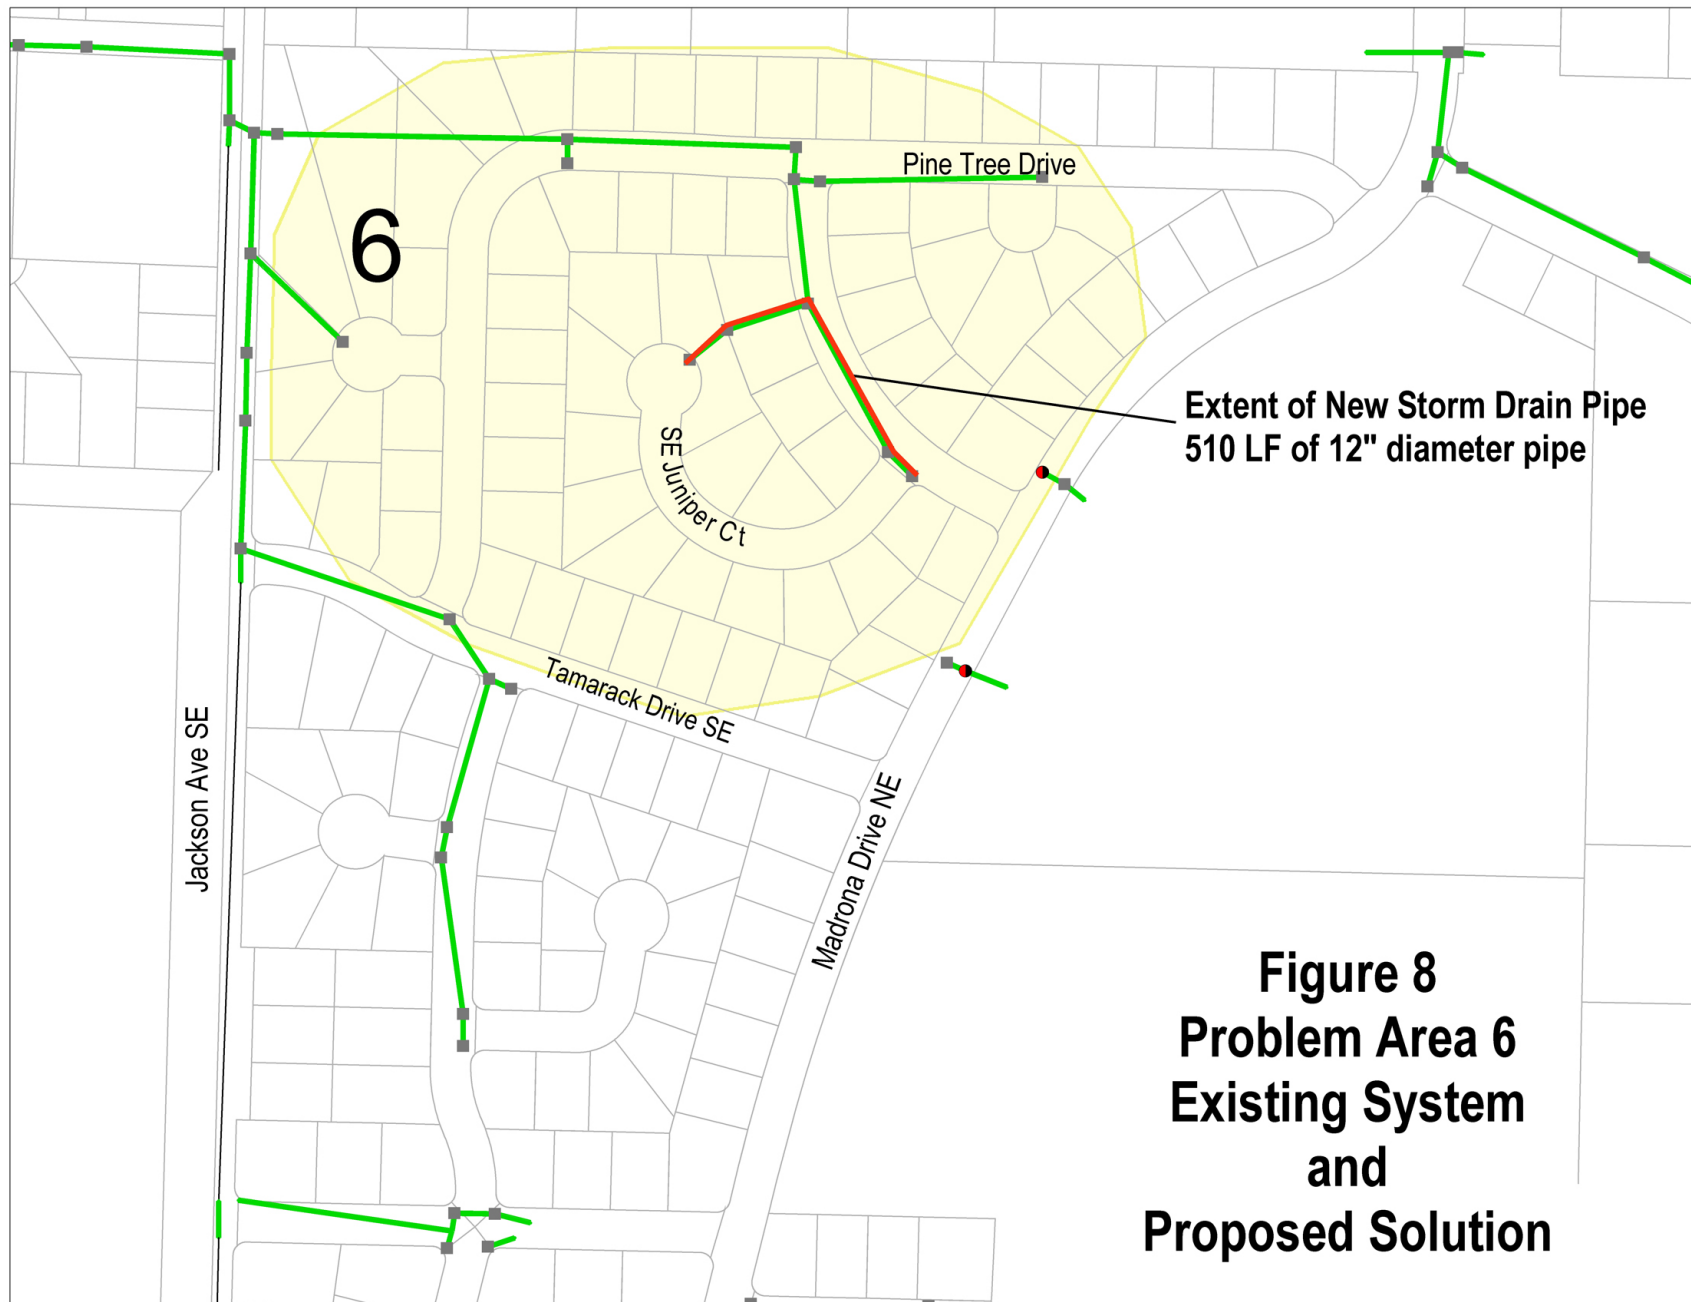
Figure 8
Problem Area 6
Existing System
and
Proposed Solution
